Garden Street Live Oak Report

Garden St Island Jefferson/Brue St

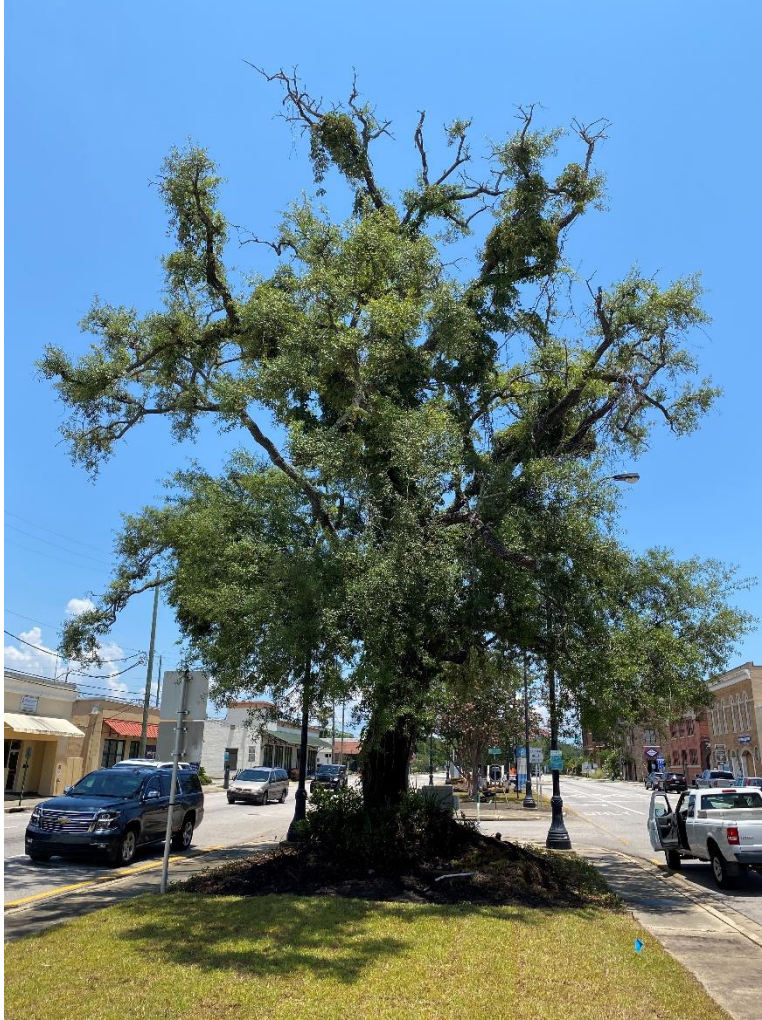
The Live oak, *Quercus virginiana*, located in the center island median of Garden Street and Brue Street, is a 34-inch dbh heritage oak. The current decline in tree health and vigor is directly related to the 2 to 3-feet of excessive soil accumulation at the lower trunk. To enable this tree to regain health and vigor this excessive soil needs to be removed. Once the primary issue of soil has been addressed, the tree may be pruned to remove any vines and dead limbs that have accumulated through the tree crown.

Objective: removal of excessive soil and debris accumulation at tree trunk base. Soil and debris shall be removed to expose the trunk flare and root/trunk interphase. Prune Tree Crown to remove dead diseased or damaged limbs and branches greater than 1-inch diameter throughout tree crown.

Specifications: remove excessive soil with the use of an air excavation device/air excavator, to remove soil and accumulated debris from the lower trunk area until the trunk/root interphase has been exposed and identified.

Remove any adventitious rooting that has developed within the excessive soil and debris and prune any crossing or circling roots exposed.

Provide vertical mulching under the tree crown, 100 to 150, holes 5 to 6-inches diameter, 6 to 9-inches deep, between 2 to 3-feet apart, with holes filled with biochar or suitable organic material to improve tree vigor and reduce compaction within the critical root zone.

Prune Tree Crown to remove dead diseased or damaged limbs and branches greater than 1-inch diameter throughout tree crown.

Reduce over-extended limb and branches that have grown over Garden Street to provide 16 to 18-feet elevation over roadway.

Remove all debris and excessive soil from site and restore current landscape onsite. All work shall conform to all ANSI A300 and Z133 work and safety standards.
