# **Tree Assessment**

## **A Street Revitalization Plan**

City of Pensacola Arborist

March 29, 2022

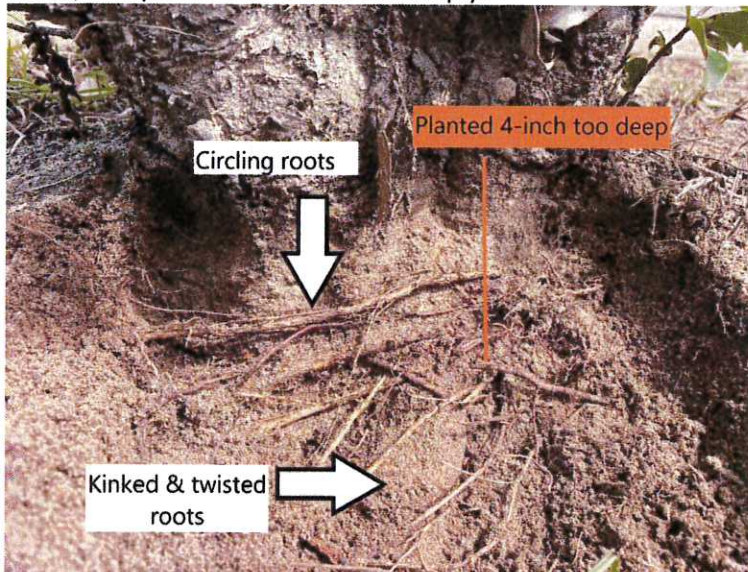
**Tree #2:** 5-in DBH, 20-ft height. Circling roots, kinked & twisted buttress roots, tree planted 4 ½ inches too deeply.

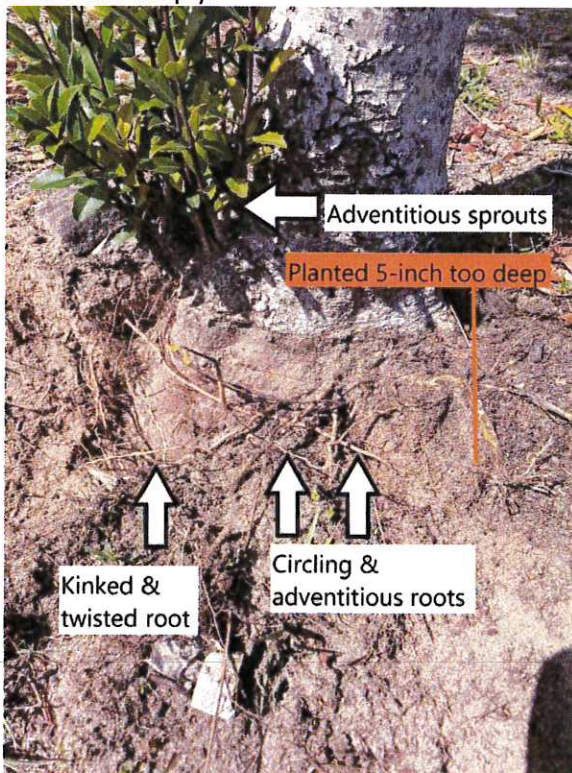
**Tree #3:** 4.5-in. DBH, 21-ft height. Circling roots, kinked & twisted buttress roots, tree planted 6-inches too deeply.

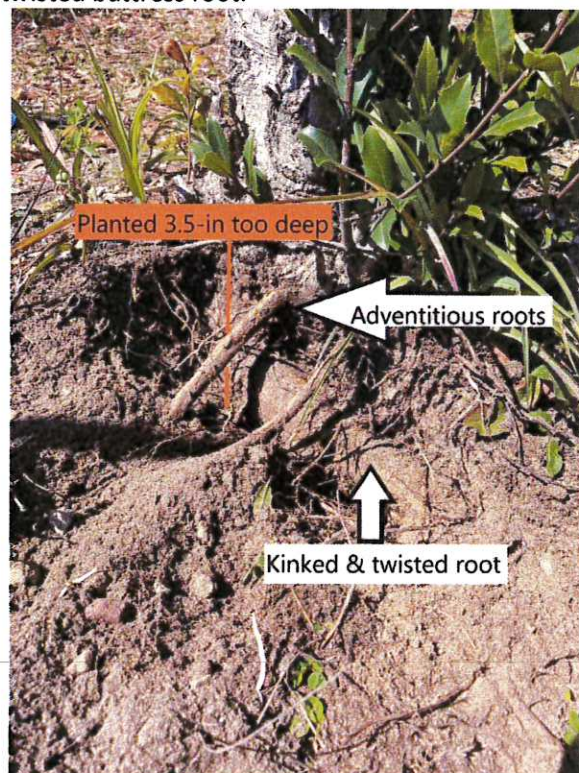
**Tree #4:** 5.5-in. DBH, 17-ft height, Planted 3.5-inches too deep, adventitious rooting, kinked & twisted buttress root.

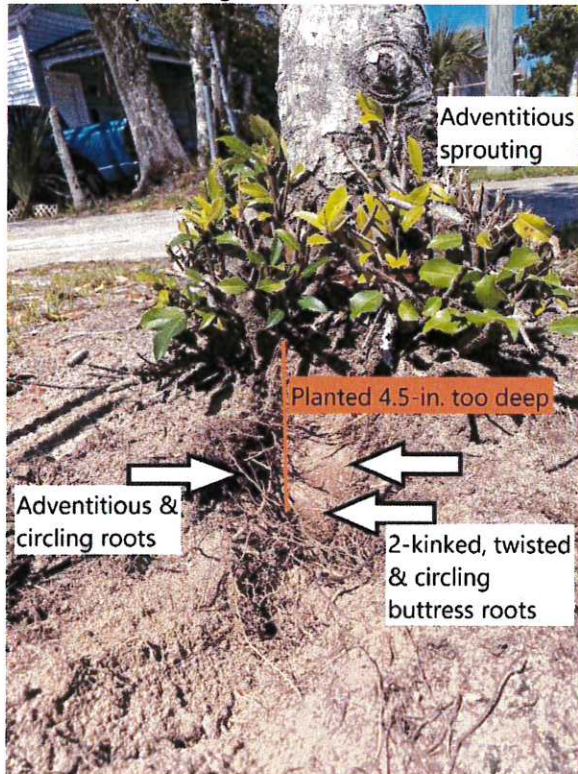
**Tree #5:** 3.5-in. DBH, 16 ½ ft height, planted 4 ½ inches too deeply, Kinked & twisted Buttress roots, adventitious & circling roots, excessive sprouting.

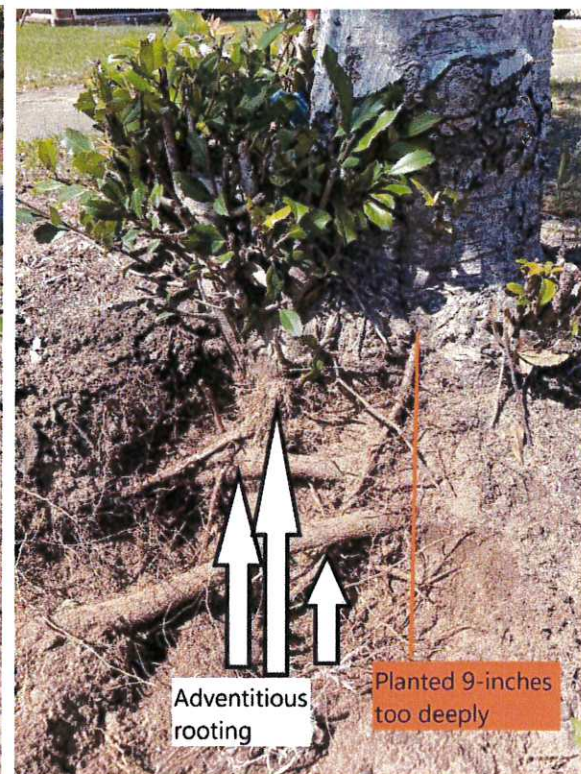
**Tree #6:** 6-in. DBH, 20 ft height, planted 9-inches too deeply, Multiple adventitious roots developing, epicormic sprout development along trunk at soil level.

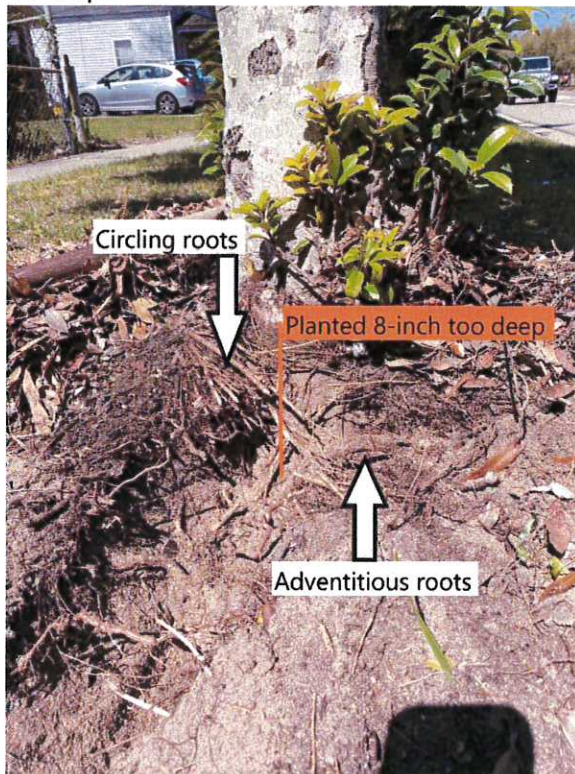
**Tree#8:** 5.5-in. DBH, 22-ft height, planted 8-inches too deeply, Circling roots, adventitious root development.

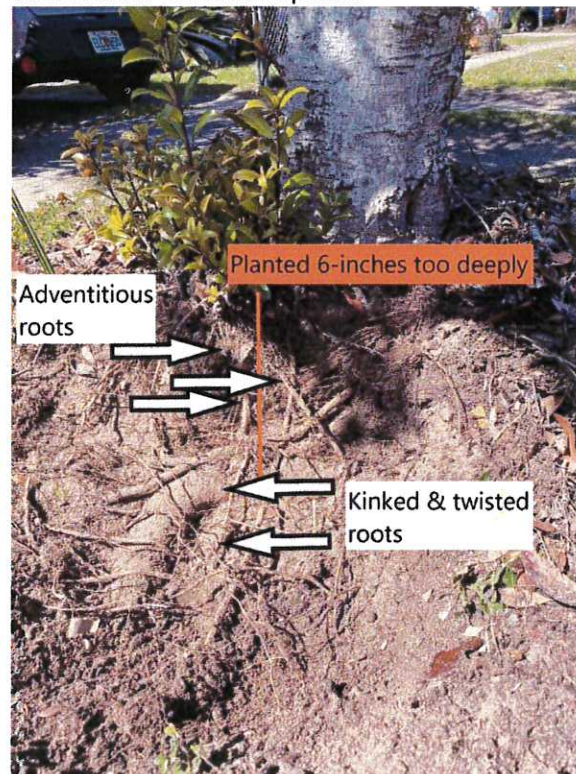
**Tree #9:** 6.5-in. DBH, 20-ft height, planted 6-inches too deeply, Kinked & Twisted support roots, adventitious root development

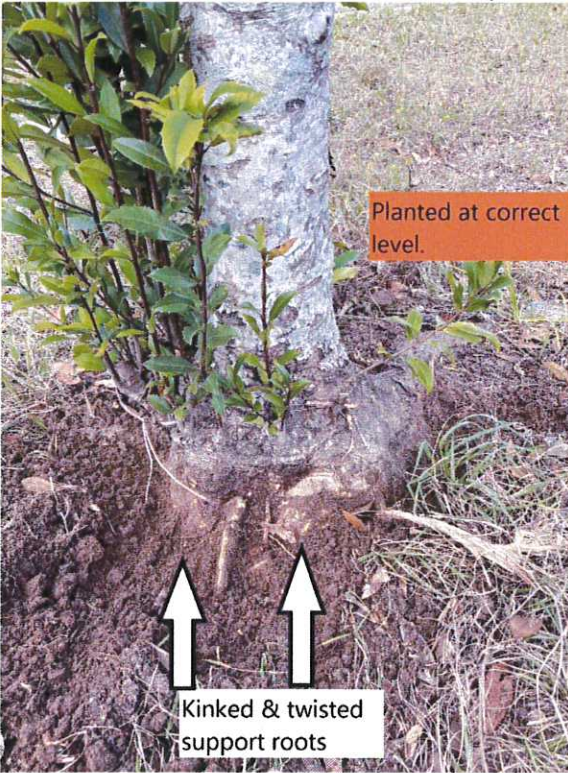
**Tree #17:** 3.5-in. DBH, 19-ft height, planted at correct level, Kinked & twisted root development.

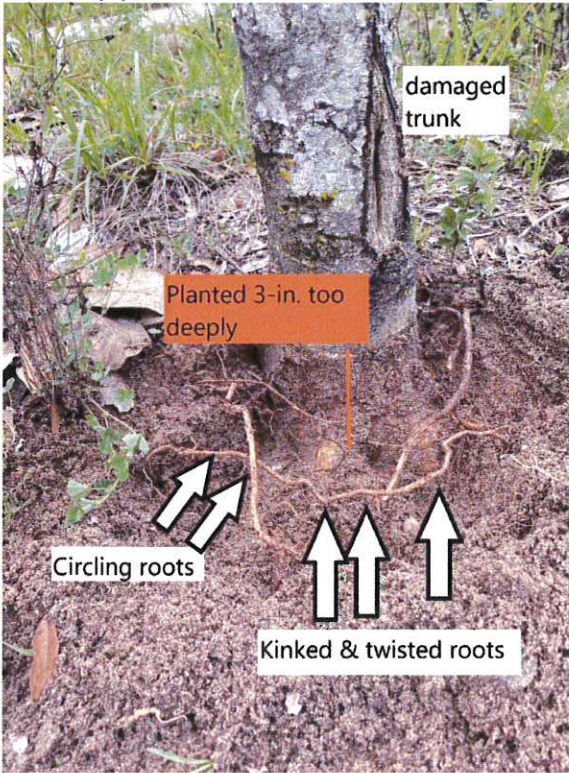
**Tree #23:** 5.5-in. DBH, 18.5-ft height, planted 3-in. too deeply. Kinked & twisted roots, circling roots.
