City of Pensacola

Zoning Board of Adjustments

Agenda - Final

2. [23-00489](#) ZBA 2023-010
4590 CHRISTY DRIVE
R-1AAA

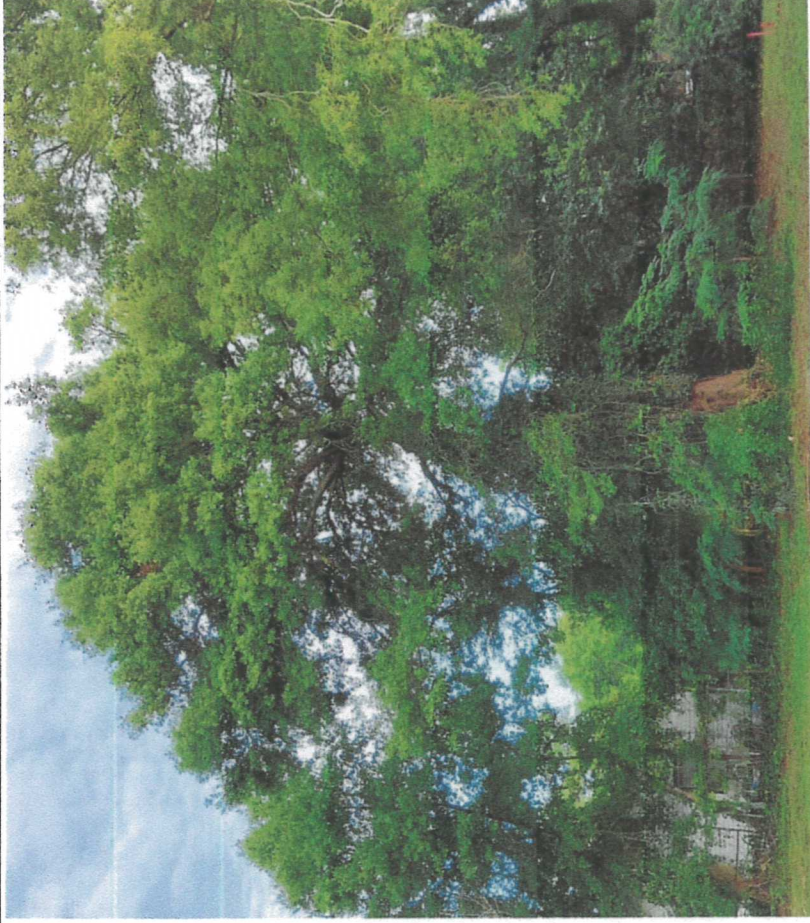
Photo 1

Overview of Tree 1, facing west. Note the dense vine cover present throughout the tree.

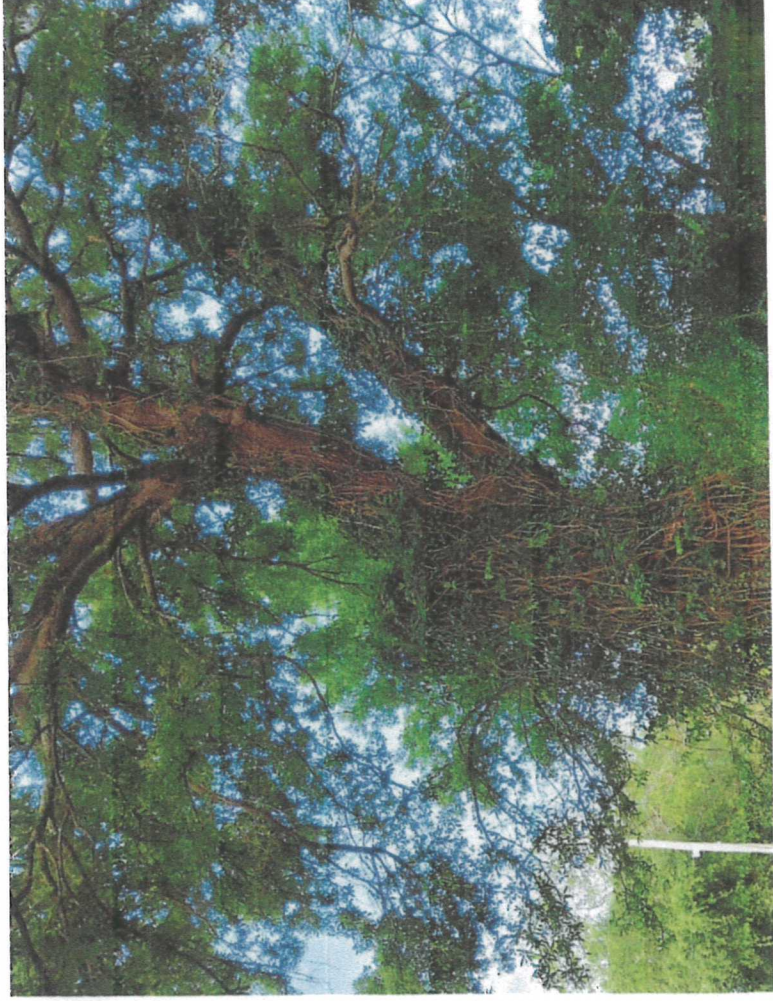
Photo 2

Condition of Concern: Large dead broken branch in crown

The likelihood of failure for the large dead broken branch within the crown is **possible**.

- The likelihood of impact for the people in the yard of 4590 is **very low**, resulting in a likelihood of failure and impact of **unlikely**. The consequences for this scenario are **severe**, resulting in a risk rating of **low**.

Overview of large dead branch on Tree 1, facing west.

The risk rating for this condition of concern is **low**. Mitigation options for this scenario include removing the large dead branch from the crown and/or restricting access; mitigation options provided result in a residual risk rating of **low**.

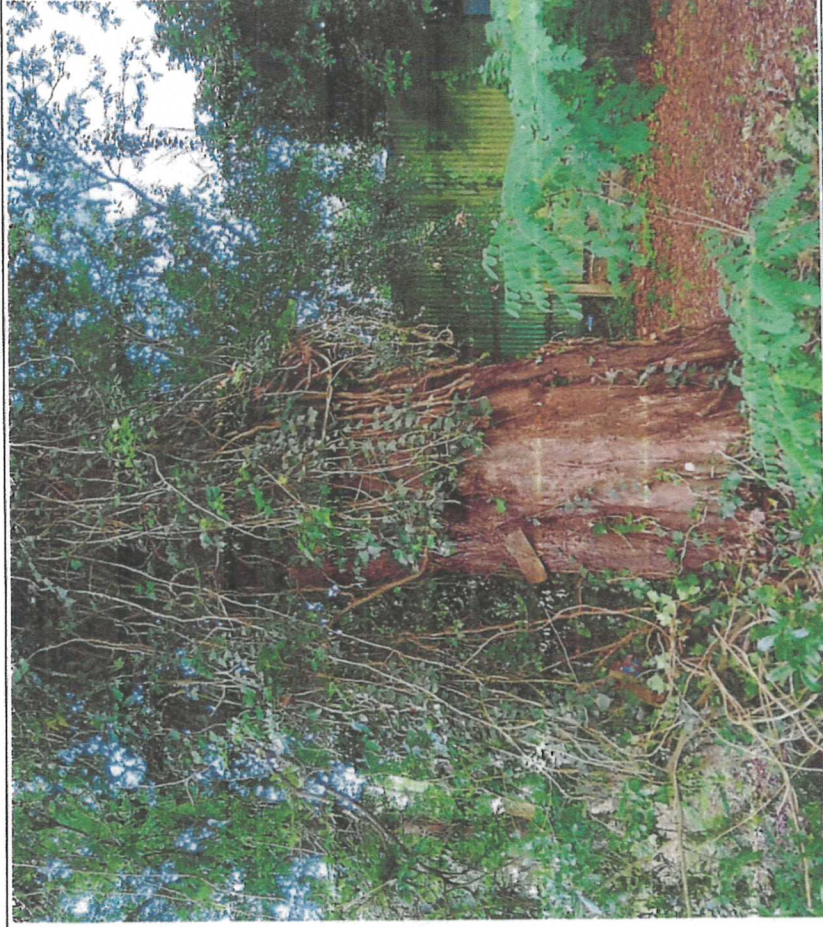
Condition of Concern: Large wound on northeast side of trunk (from grade to 14ft above grade)

The likelihood of failure for the whole tree at the large wound on the northeast side of the trunk (from grade to 14ft above grade) is **possible**.

- The likelihood of impact for the house located at (4570) is **high**, resulting in a likelihood of failure and impact of **somewhat likely**. The consequences of this scenario are **severe**, resulting in a risk rating of **moderate**.

- The likelihood of impact for the shed (4570) is **high**, resulting in a likelihood of failure and impact of **somewhat likely**. The consequences of this scenario are **severe**, resulting in a risk rating of **moderate**.

Photo 3
View of dead tissue on the
tension side of the trunk,
facing west.

The risk rating for this condition of concern is **moderate**. Mitigation options for this scenario include vine removal and end weight reduction pruning; mitigation options provided result in a residual risk rating of **moderate**.

It is recommended that a Level 3 Advanced Assessment be performed on Tree 1 to further examine the extent of possible decay within the large wound on the northeast portion of the trunk and the cavity associated with the previous leader failure. Arborists performed drilling of the trunk to obtain information about the resistance of the wood around the wounded area at the base of the tree. Decay was encountered in 40% of drilling samples conducted. It is recommended that the technique sonic tomography be applied to this tree to view the characteristics and extent of the decay within the trunk.

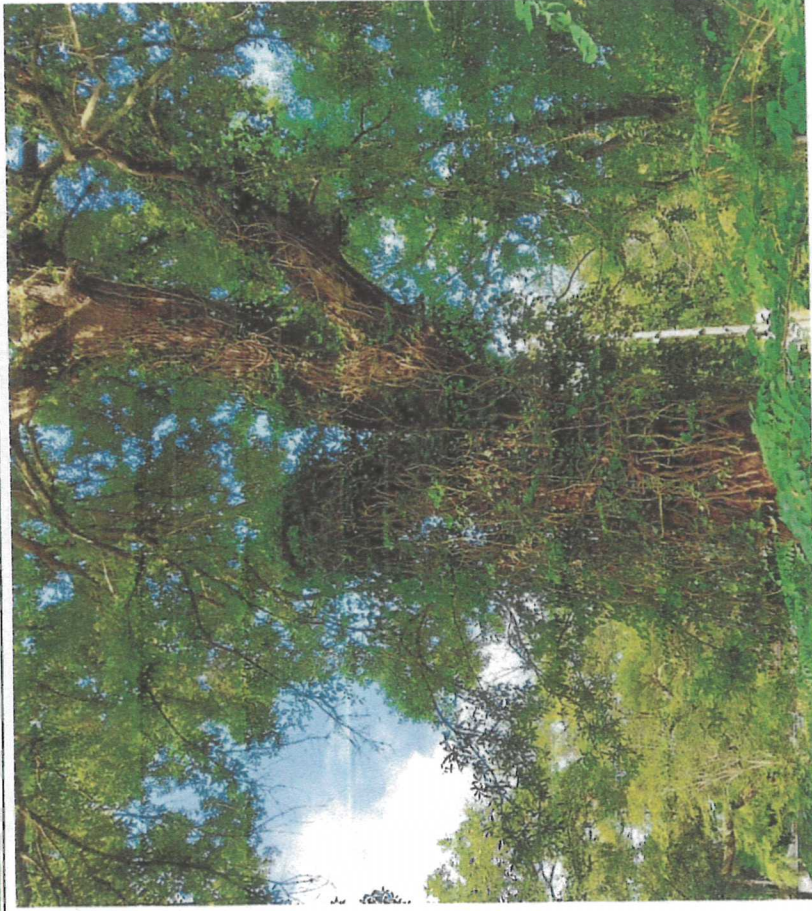
Condition of Concern: Cavity associated with the previous leader failure

The likelihood of failure at the cavity associated with the previous leader failure is **possible**.

- The likelihood of impact for the house (4570) is **high**, resulting in a likelihood of failure and impact of **somewhat likely**. The consequences of this scenario are **significant**, resulting in a risk rating of **moderate**.

- The likelihood of impact for the shed (4570) is **high**, resulting in a likelihood of failure and impact of **somewhat likely**. The consequences of this scenario are **significant**, resulting in a risk rating of **moderate**.

Photo 4
View of dead tissue at the
previous leader failure,
facing south.

The risk rating for this condition of concern is **moderate**. Mitigation options for this scenario include vine removal and end weight reduction pruning; mitigation options provided will result in a residual risk rating of **moderate**.

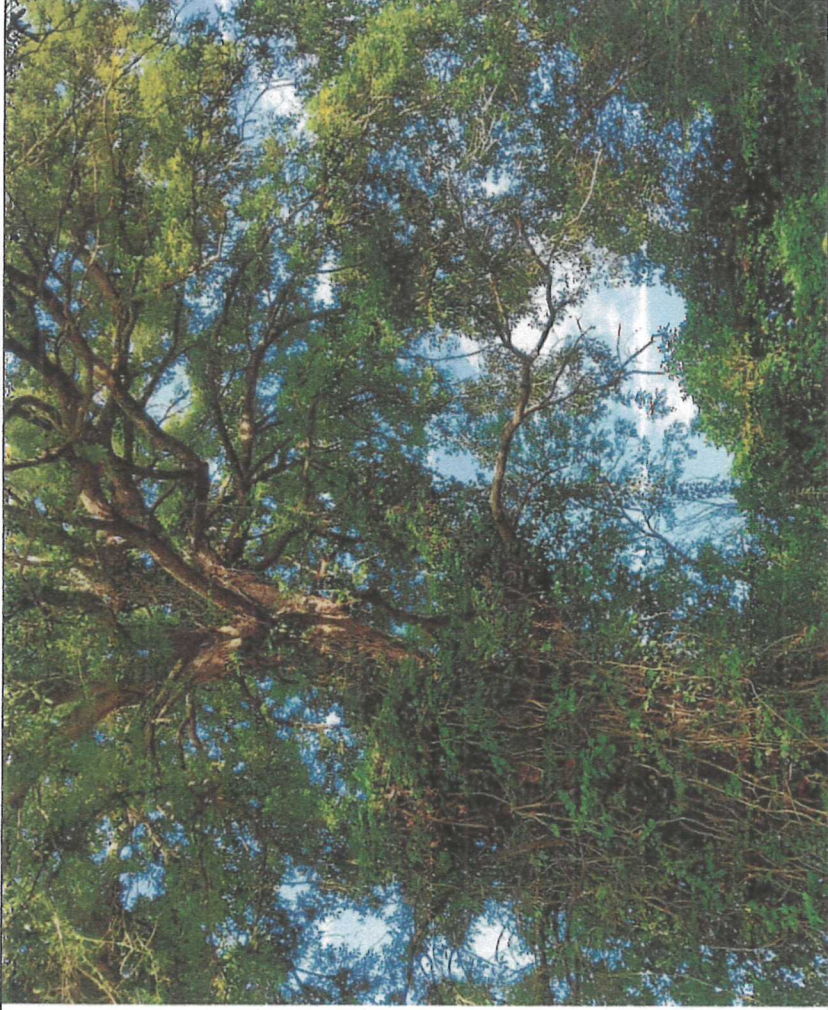
Condition of Concern: Dead branches in crown

The likelihood of failure for the dead branches within the crown is **imminent**.

- The likelihood of impact for the people in the yard of 4590 is **very low**, resulting in a likelihood of failure and impact of **unlikely**. The consequences for this scenario are **severe**, resulting in a risk rating of **low**.

Photo 5
View of dead branches in
crown of Tree 1.

The risk rating for this condition of concern is **low**. Mitigation options for this scenario include removing dead branches from the crown and/or restricting access; mitigation options provided result in a residual risk rating of **low**.

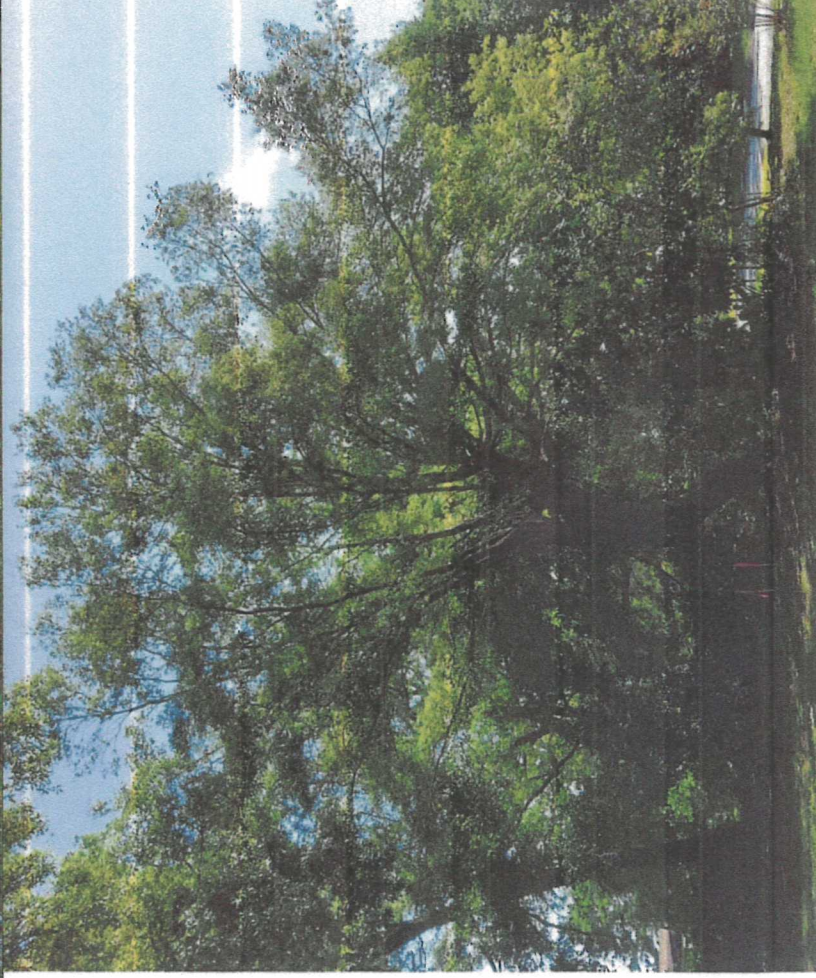
Photo 6
Overview of Tree 2, facing
north.

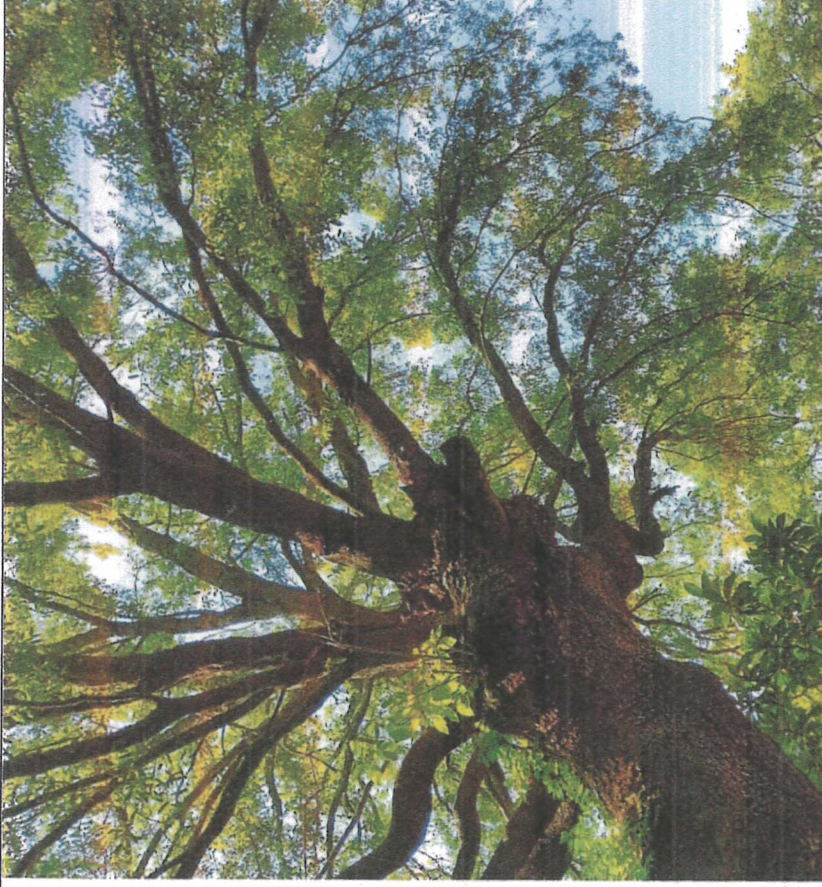
Photo 7

Condition of Concern: Cavity on the northern leader

View of cavity below broken leader with a beauty berry inside of the cavity Tree 2.

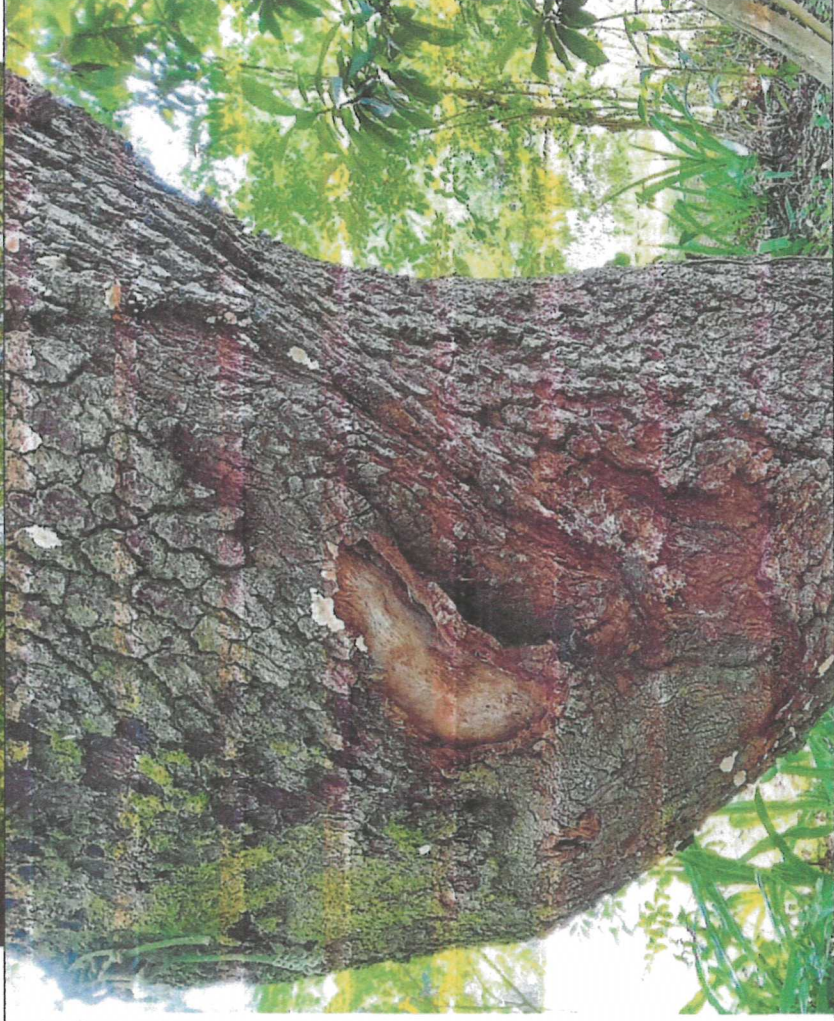
Photo 8

Condition of Concern: Minor trunk wound from equipment

The likelihood of failure from the minor trunk wound is **improbable**.

View of trunk wound on Tree 2, facing east.

The risk rating for this condition of concern is **low**. Mitigation options for this scenario include end weight reduction pruning; mitigation options provided result in a residual risk rating of **low**.

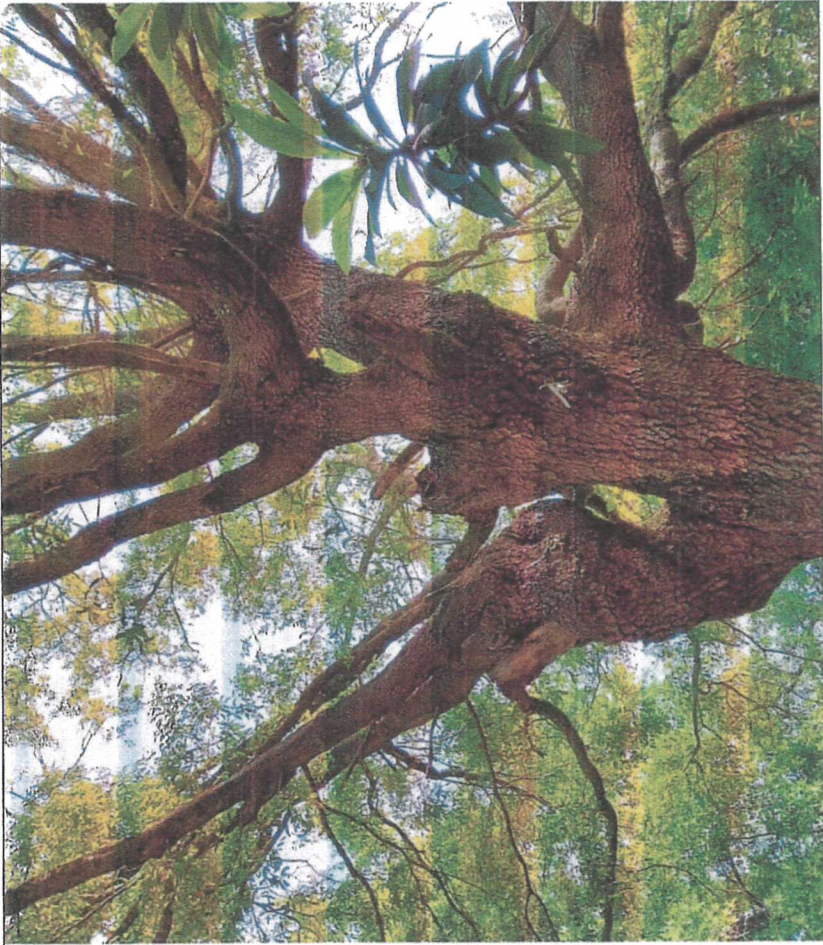
Condition of Concern: Southern leader failure with sprouting

The likelihood of failure at the cavity located at the southern leader failure with sprouting is **possible**.

Condition of Concern: Northern leader failure with sprouting

Photo 9
View of broken leaders with
sprouts in Tree 2.

- The highest risk rating for the southern leader failure with sprouting is **low**; mitigation options for this scenario includes end weight reduction pruning and/or restricting access, resulting in a residual risk rating of **low**.

- The highest risk rating for the northern leader failure with sprouting is **low**; mitigation options for this scenario includes end weight reduction pruning and/or restricting access, resulting in a residual risk rating of **low**.

The risk rating for this condition of concern is **low**. Mitigation options for this scenario include end weight reduction pruning and/or restricting access to the area; mitigation options provided result in a residual risk rating of **low**.
