Inspection Report

1015 N. 'E' St.

Pensacola, FL

2/19/2020

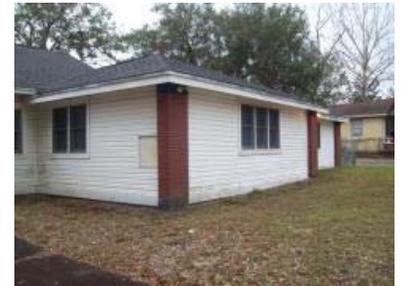
MATERIAL: Vinyl siding with vinyl soffit and trim.

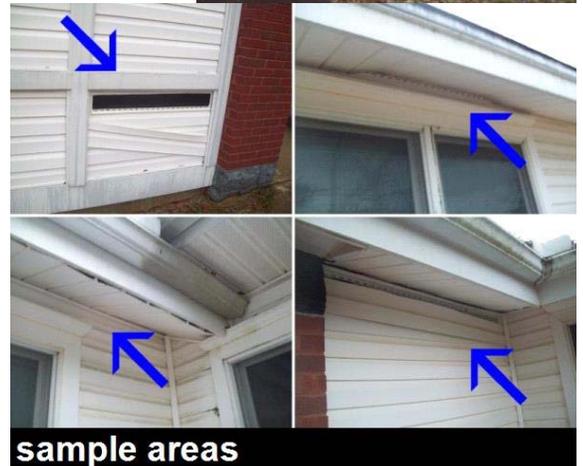
There are several areas around the building where the siding is loose (front) and where the soffit's panels are loose and/or out of position. Have a vinyl contractor start in the front where the loose siding panel is and work their way around the building securing any loose soffit and/or trim.

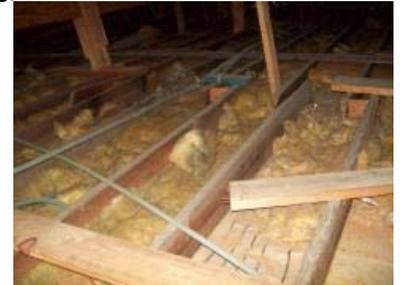
Fiberglass batts.

6 +/- inches = R-19 +/- . **The current insulation is compacted and the true R-factor at this point in time may be less than that originally installed. Installation of additional insulation is recommended.**

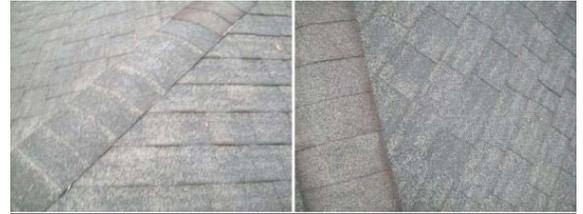
shingle wear

The roof shingles are at or near the end of their useful life. A licensed roofing contractor should be called for a further evaluation and make any other repairs as needed.

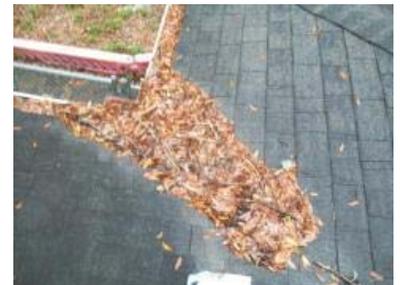
Metal, general conditions are OK, however the gutters need to be cleared from all leaves and debris. Continue to keep the gutters clean as part of routine maintenance.

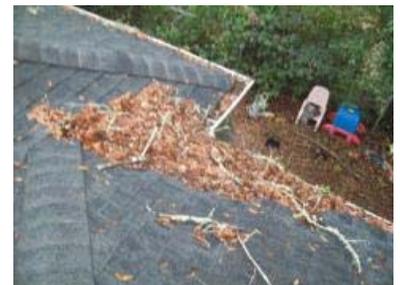
The leaves and tree debris need to be cleaned off and kept off of the roof surface as much as possible.

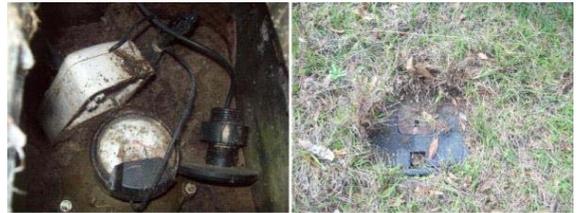
backflow preventer valve under box

The water meter is located in the side yard, no visible problems were observed, but the water service was not on.

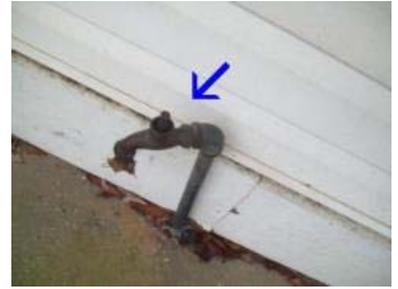
The faucet handle for the hose faucet on the rear side is missing (been removed for obvious daycare reasons)?

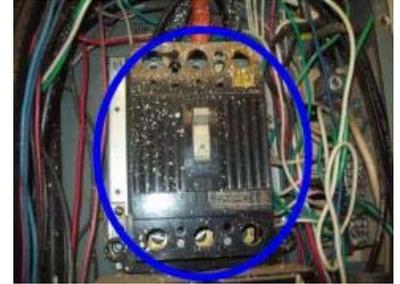
MAIN PANEL POWER SIZE: 200 amp +/- . The ampacity of the main service panel is adequate for the structure as it is presently being used. A 200 amp service disconnect circuit breaker was present at the service panel.

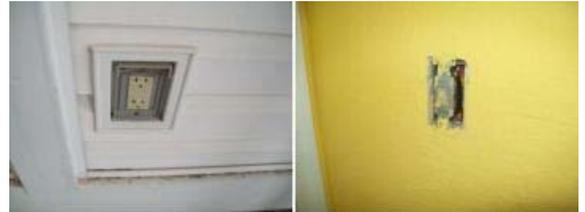
A representative sampling of switches and outlets were tested. As a whole, outlets and switches throughout the building are in good working / serviceable condition with the following exceptions - the exterior GFCI outlet to the left of the front door has a broken weatherproof cover and a couple of switch / outlet coverplates are missing. Furnishings / stored items prevent access and testing at some outlets and switches.

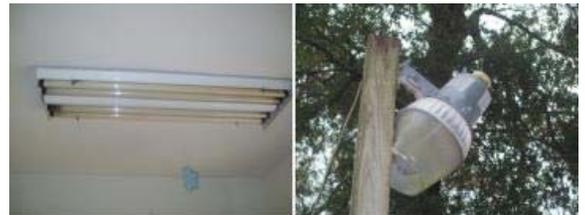
- 1. Several of the interior lights are not working. When light fixtures are not working it could be a bulb issue, a switch issue, or a fixture issue but you cannot be sure until all light fixtures have good working bulbs.**
- 2. There are several light fixtures with missing bulb covers.**
- 3. The exterior rear safety light appears broken.**

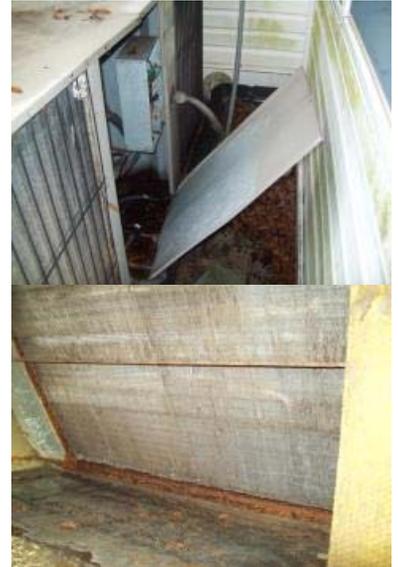
Not determined due to it not being operated. Even if the thermostat was working, I would not have operated the units due to the exterior cover being unscrewed and open to the elements.

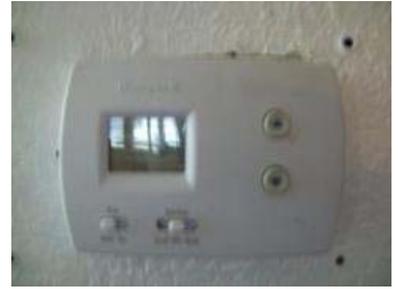
The thermostat has a LED readout screen that is not displaying any information - mentioned earlier.

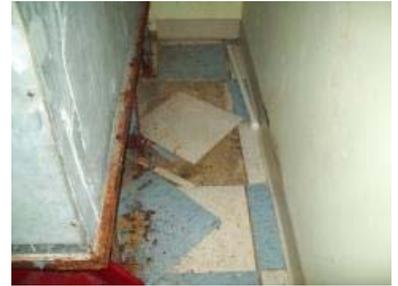
OK, fair condition. Due to past leaks some of the vinyl floor tile are loose.

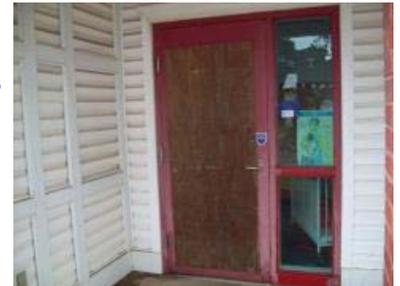
The front door's glass has been broken and it currently has a piece of plywood covering what is left of the broken glass panel. The front door does operate and lock OK.

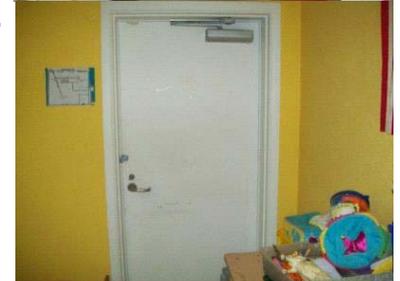
The south side door is stuck shut - free as needed. The other front door and rear door operate and lock OK.

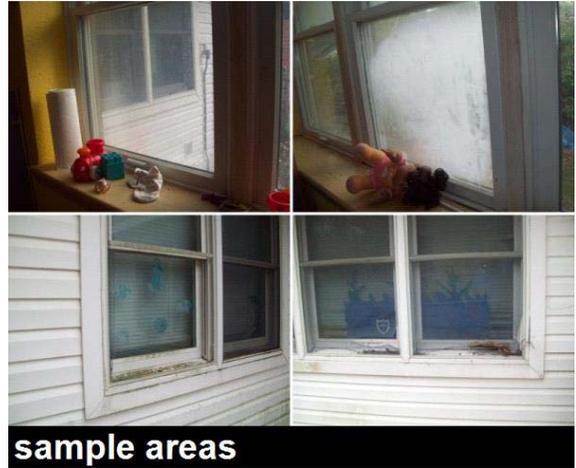
1. Four of the windows I could access have a spiral sash balance (which holds up the window) that is defective or has come loose.
2. Several of the windows' insulated glass have a fogged look, indicating an inner seal failure. Because minor fogging and possibly minor cracking of any glass can be difficult to detect, for various reasons, such as weather conditions, uncleanliness, and limited access, it is recommended to have all of the insulated glass windows and doors reviewed by the professional glass contractor, when on site measuring for the replacement glass. They can best prepare a detailed list of the number of fogged window & door panels which need to be replaced.
3. Multiple screens were either missing or damaged.

Make all minor hardware repairs and/or glass improvements as needed.

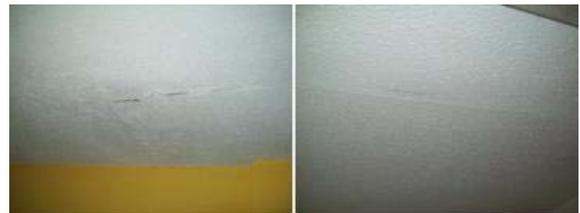
TYPE & CONDITION: Drywall, general conditions are fair to OK. Water stains were noted and are dry at this time. Make inquiry with the seller as to the history of leaks.

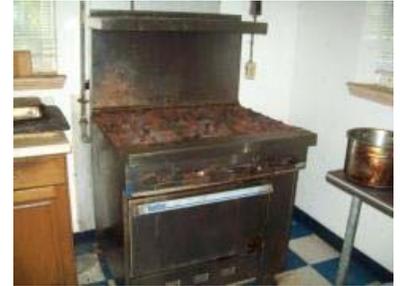
TYPE/CONDITION: **Gas range - no gas service at this time but the range and oven are rusty but appear to be OK. Check before closing that all burners and the oven and broiler are operating correctly.**

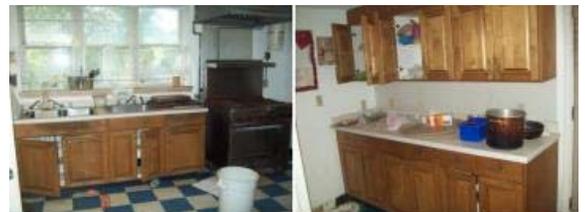
COUNTERS AND CABINETS: **The cabinets and tops are in fair & serviceable condition as viewed. Cleaning of the cabinets is needed.**

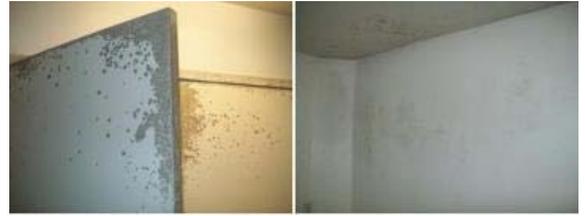
WALLS/CEILINGS/FLOORS: **The walls and closet doors in the kitchen have some mildew and what looks like mold that will need to be cleaned.**

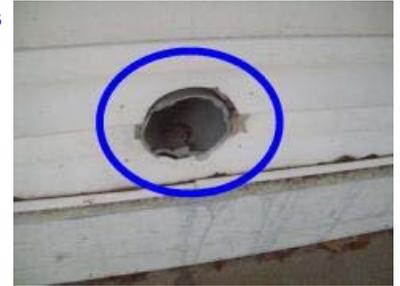
CONDITION: **The exterior dryer vent cover is missing and needs to be replaced.**

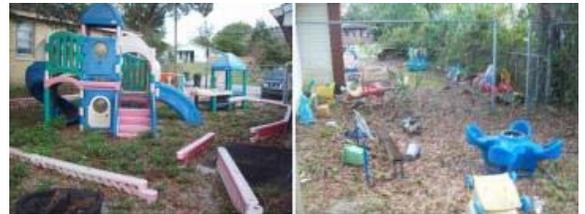
CONDITION: **Maintenance needed, the play set and toys need a thorough cleaning.**
